The Fire Resistance Performance Of Two, Single-Acting, Single-Leaf Doorsets, When Tested In Accordance With BS 476: Part 22: 1987, Clause 6.

WF436874

Zenova Ltd

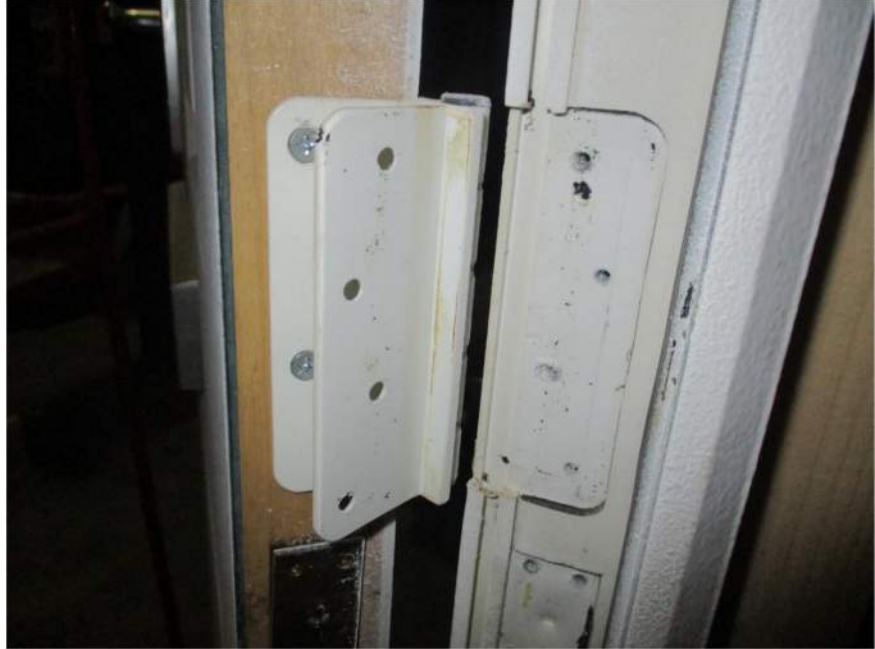
Hinge intumescent  
interruption

19. Hinges	
Supplier	Masterdor butt type hinges*
Reference	HNG13338*
Quantity	3*
Primary material	Steel*
Size	
i. knuckle	Unknown diameter x 102mm high **
ii. blades	100 mm high x 40mm wide x 1mm thick*
Fixings	
i. type	Unknown**
ii. material	Unknown**
iii. sizes	Unknown dimensions**
iv. number off per blade	4 per blade*
Position of each hinge relative to the head of the leaf	Fitted 100mm, 940mm and 1684mm from leaf head*
Details of intumescent protection	None fitted
Interruptions to Intumescent within the frame reveal	The hinge blade fully interrupts the seal in the frame reveal*

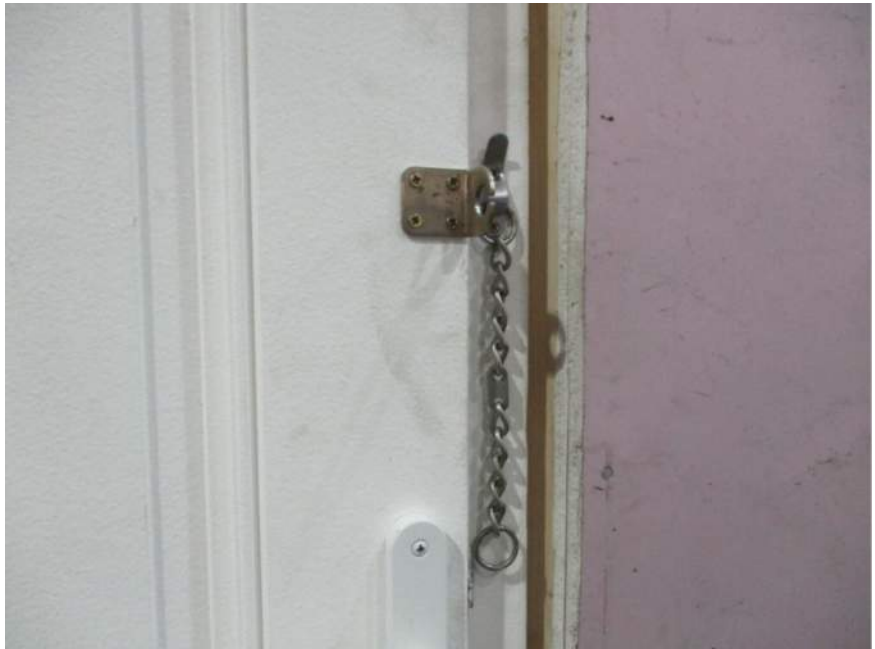
Security chain

<b>24. Security Chain</b>	Doorset B
Manufacturer	Unknown**
Reference	Unknown**
Material	Unknown**
Face plate to leaf	Unknown**
Face plate to frame	Unknown**
Chain	Unknown**
Overall size	
Face plate to leaf	Unknown dimensions**
Face plate to frame	Unknown dimensions**
Location	Fitted on the exposed face of Doorset B
Fixing method	Unknown**
Details of intumescent protection	Unknown**

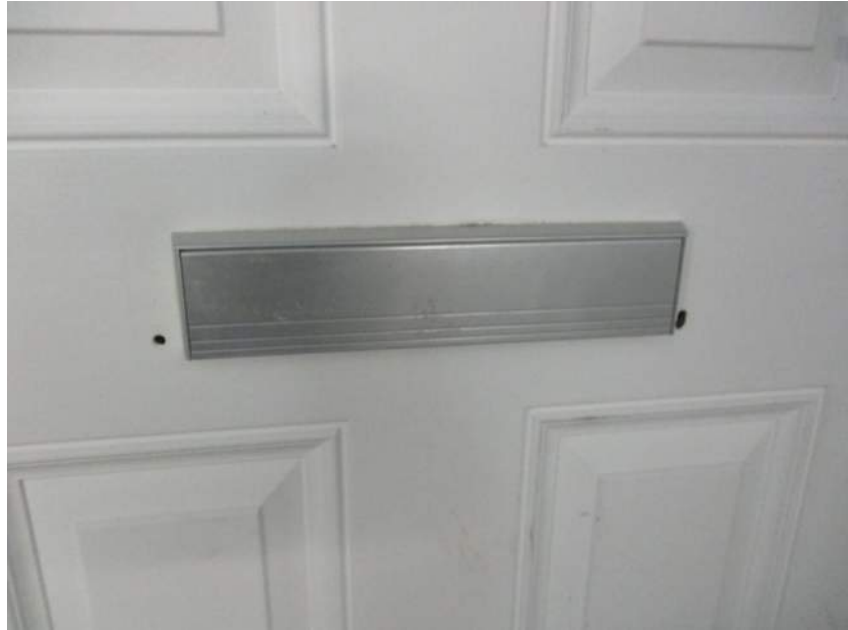
Letter plate

<b>25. Letter plate</b>	
Manufacturer	Unknown**
Reference	Unknown**
Material	Unknown**
Overall size	
Footprint	300 mm wide x 70 mm high
Channel	Unknown dimensions**
Cut out	Unknown dimensions**
Location	Fitted 1060 mm from the head of the leaf
Fixing method	Unknown**
Details of intumescent protection	Unknown**

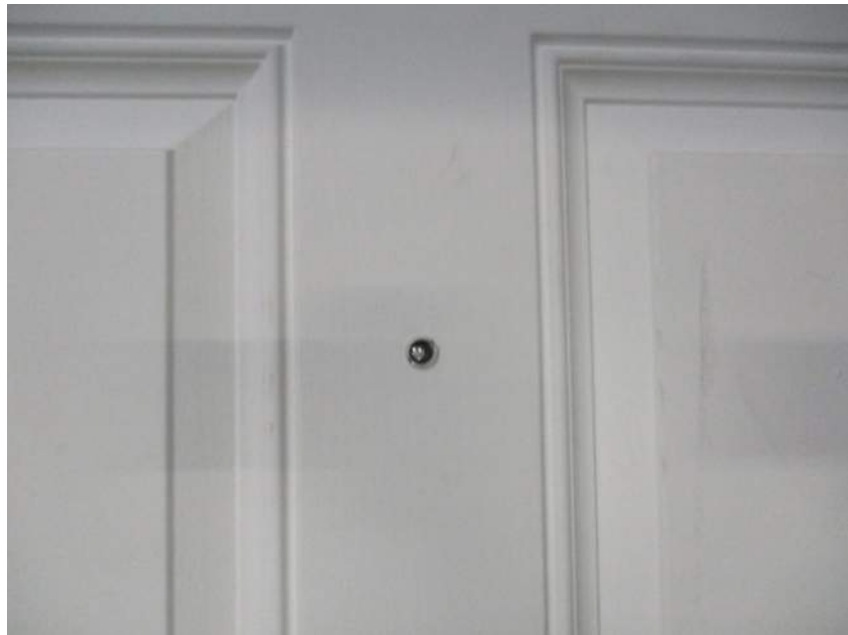
Eye Viewer

<b>23. Door viewer</b>	Doorset A
Manufacturer	Unknown**
Reference	Unknown**
Material	Unknown**
Overall size	
Body	Unknown dimensions**
Footprint	Unknown dimensions**
Cut out	Unknown dimensions**
Fixing method	Through bolt
Location	Fitted centrally 275mm from the head of Doorset A and 575mm from the head of Doorset B
Details of intumescent protection	None fitted

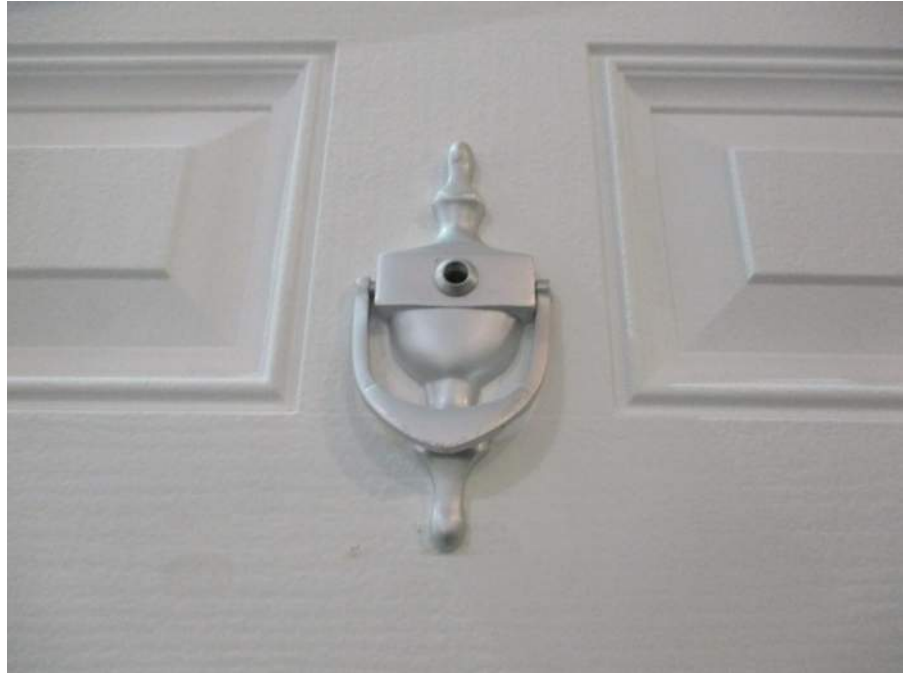
Door knocker with  
integrated viewer

<b>23.1 Door knocker with integrated viewer</b>	
Manufacturer	Unknown**
Reference	Unknown**
Material	Unknown**
Overall size	
Body	Unknown dimensions**
Footprint	Unknown dimensions**
Cut out	Unknown dimensions**
Fixing method	Through bolt
Location	Fitted centrally 275mm from the head of Doorset A and 575mm from the head of Doorset B
Details of intumescent protection	None fitted

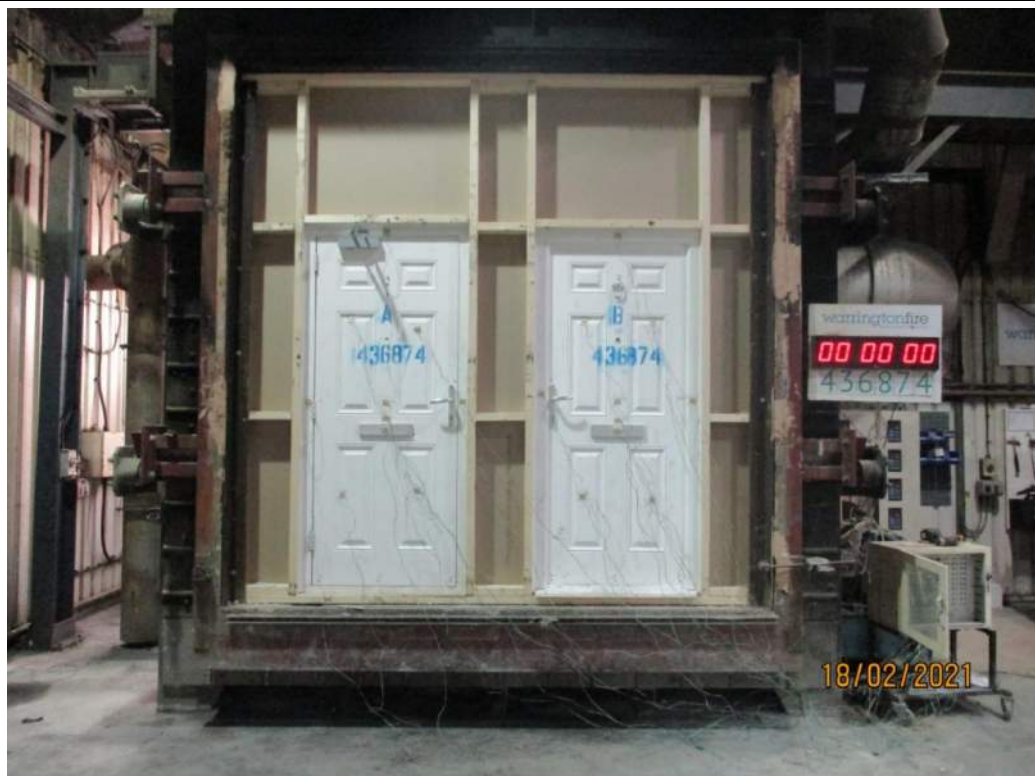
The unexposed face of the doorsets prior to testing

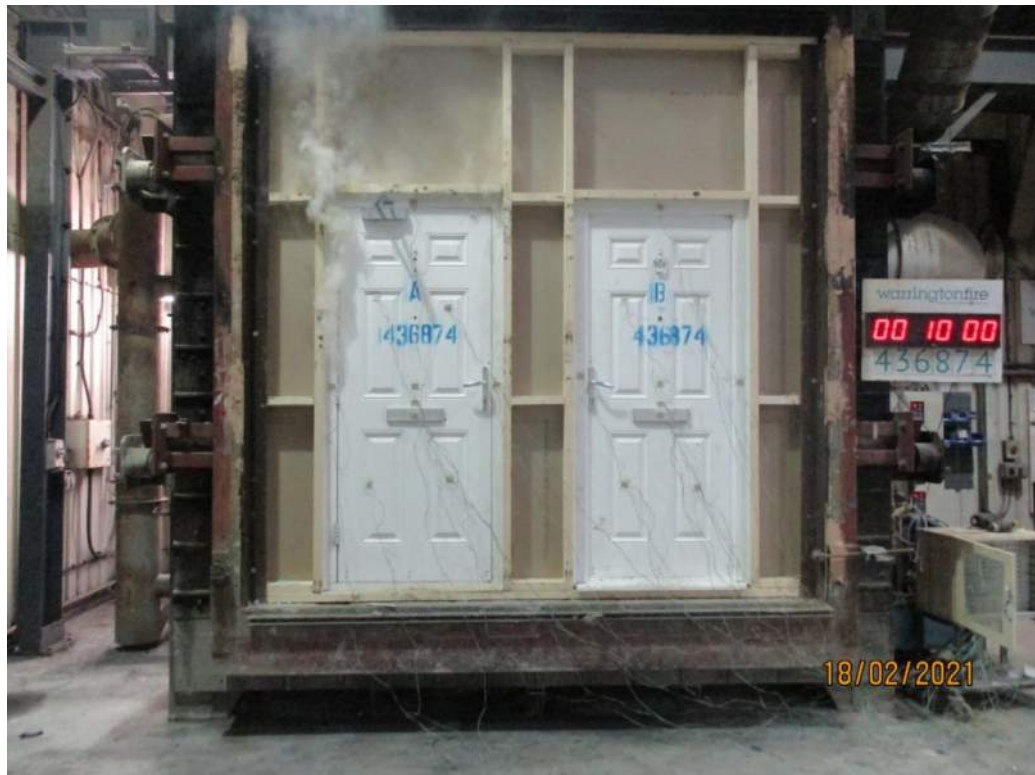
The unexposed face of the doorsets after a test duration of 10 minutes

10:30	Doorset B. There is discolouration at the top closing corner and at the top hanging corner
11:06	Doorset A. There is discolouration at the top hinge position and an increase in the smoke issuing from the middle hinge position to the top hanging corner

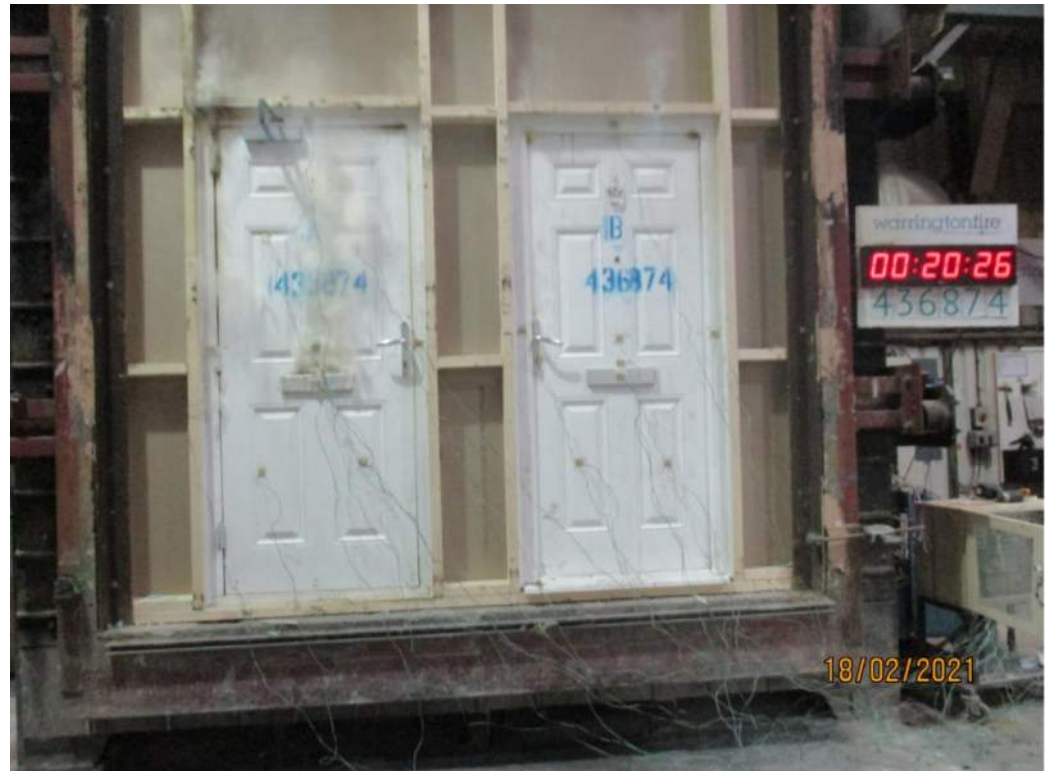
The unexposed face of the doorsets after a test duration of 20 minutes

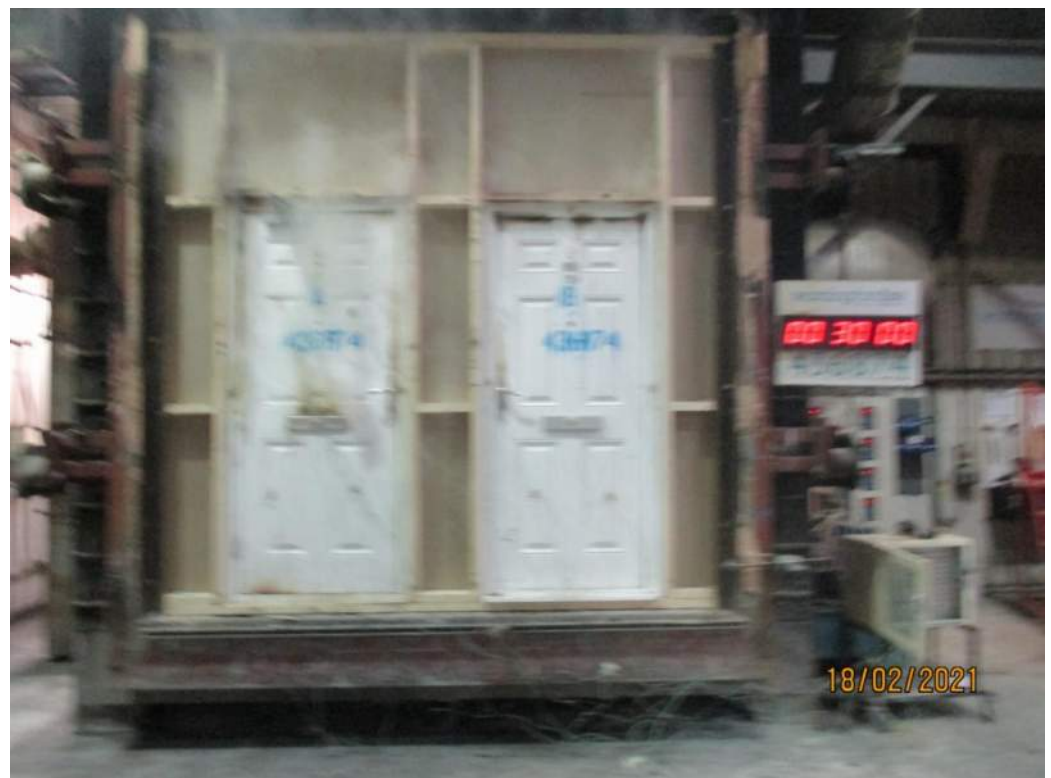
The unexposed face of the doorsets after a test duration of 30 minutes

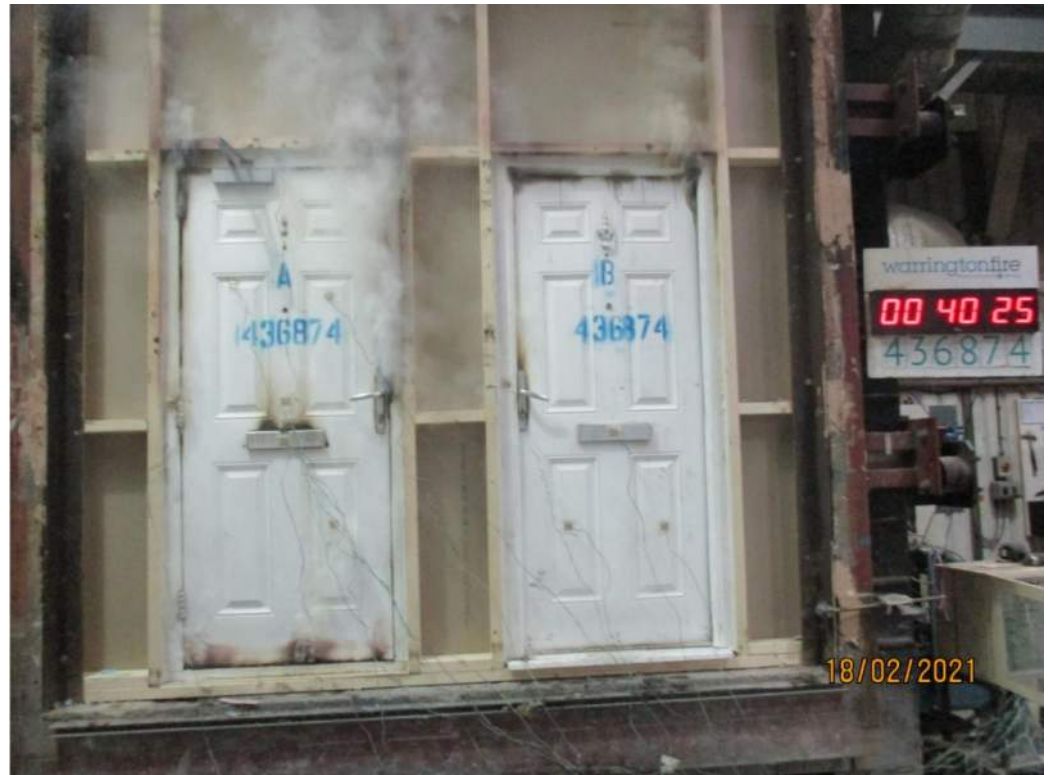
The unexposed face of the doorsets after a test duration of 40 minutes

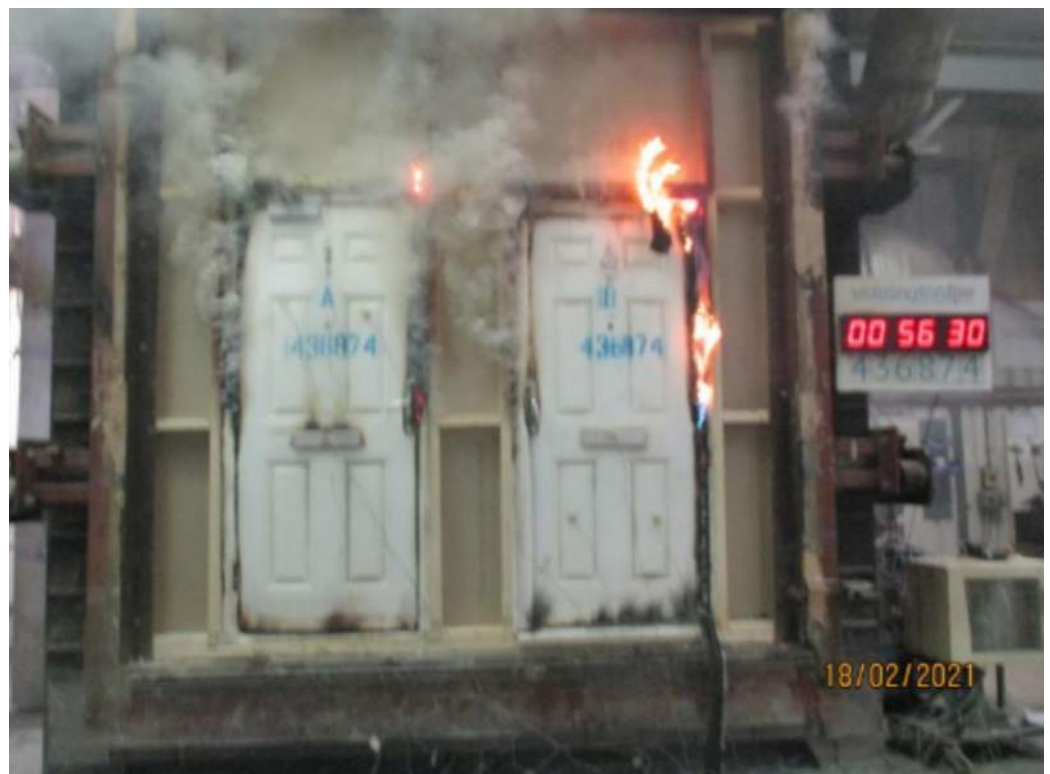
The unexposed face of the doorsets after a test duration of 56 minutes

- 56:00** Doorset B. There is continuous flaming at the middle of the jam therefore constituting **further integrity failure**
- 56:22** Doorset A. There is continuous flaming at the centre of the jam therefore constituting **integrity failure**
